Results of the Ground Surface Deformation Measurements in the Zone of Commencing the Roof Caving Exploitation and the Assessment of Its Impact on Buildings

Abstract

The article presented the results of periodic geodetic measurements, which embraced both the land surface and buildings in the zone of commencing mining exploitation. Classical geodetic measurements (levelling and tachymetric) were carried out in order to determine the size and nature of the mining ground deformation, the pace of change and their impact on the existing building development. The final results of the surface deformation were also compared with the forecasts prepared by the mine. The measurements lasted 13 months. During that period 19 measurement cycles were performed.

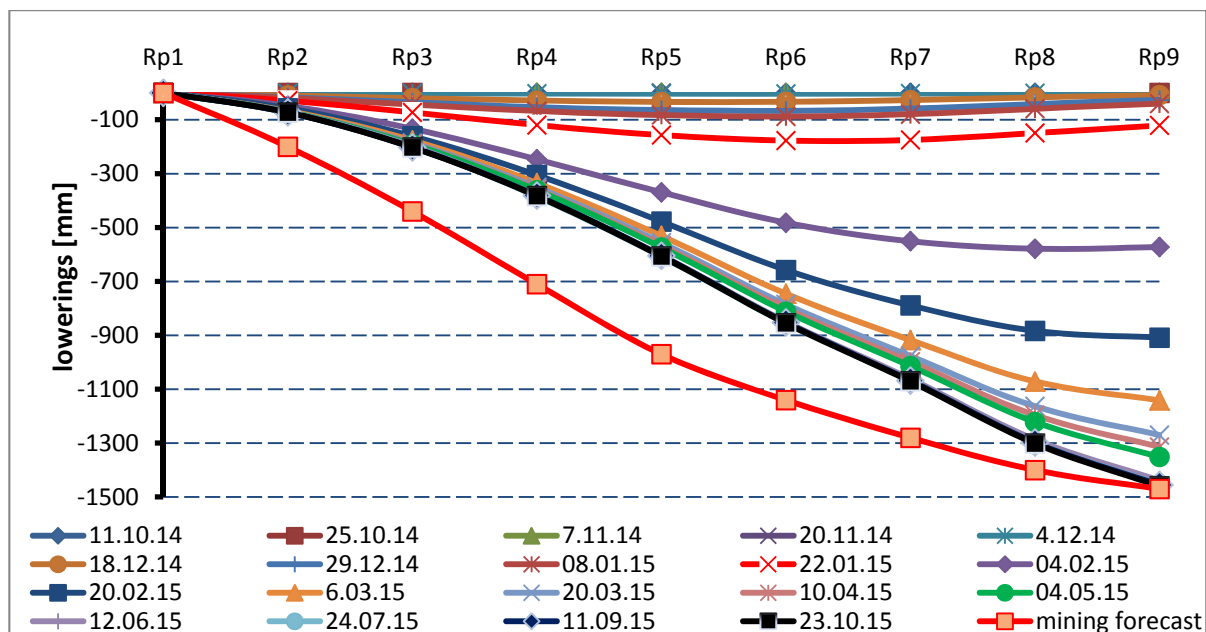
Fig. 4. Vertical deformations of the main terrain line (Source: own elaboration)

The first slight subsidence amounting to -3 mm was observed on 4.12.2014, over a month after the commencement of exploitation. After almost two months, on 18.12.2014, the first significant lowering of points on the measurement line was observed. In the first phase of deformation the ground surface deflected in the form of a concave curvature along the whole observation line, which amounted to about 193 m. Such tendency maintained till 22.01.2015. Then a sudden increase in the subsidence took place and the formation of the final subsiding trough started. Such a state maintained for the period of 2 months. On 20.03.2015 gradual extinction of further changes was observed. Observations were carried out until 25.10.2015, that is a year after the commencement of monitoring. It was decided to finish monitoring because the differences

in subsidence between particular measurements were already not bigger than 1 mm. Actually, from July till October 2015 no further changes were observed. Anticipated final deformations were also presented in the chart (Fig. 4), which was drawn up by the Coal Mine Marcel (Fig. 5).

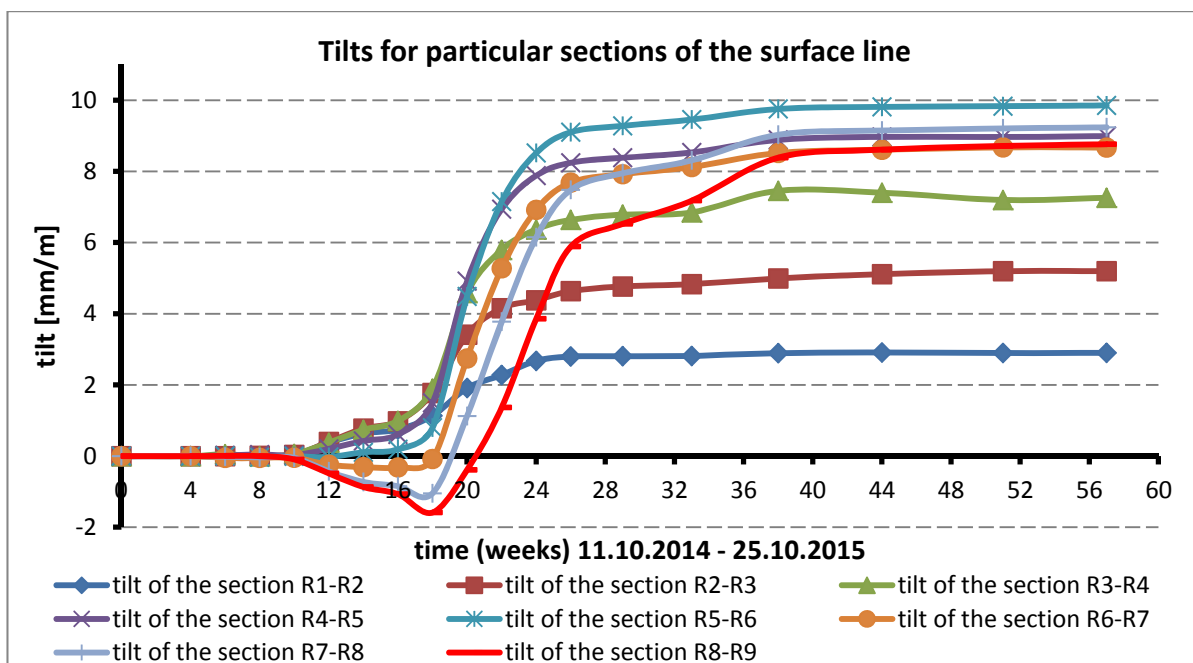
Fig. 6. Chart of the tilt for particular sections of the surface line (Source: own elaboration)

The biggest final tilts was observed in the central sections of the line. The smallest tilts were observed in the section between points 1 and 2 as well as 2 and 3, which are located farther from the edge of the exploited field. Two different natures of deformation of the monitored ground surface can be seen in the chart (Fig. 6). In the first instance, when a partial concave trough was formed over the initial exploitation edge, the tilts of sections 6-7, 7-8 and 8-9 located inside the exploited field had the opposite sign. Then, together with the progress of ground deformation, a sudden forming of a subsiding trough took place, the shape of which was similar to the final one. It resulted in the same, with regard to the sign, tilts of all sections of the monitored terrain line. Maximum tilt in the section between points 5 and 6 is about 10 mm/m. The results of the measurement indicate that the 4th category tilt was not obtained in any of the monitored sections of the line.

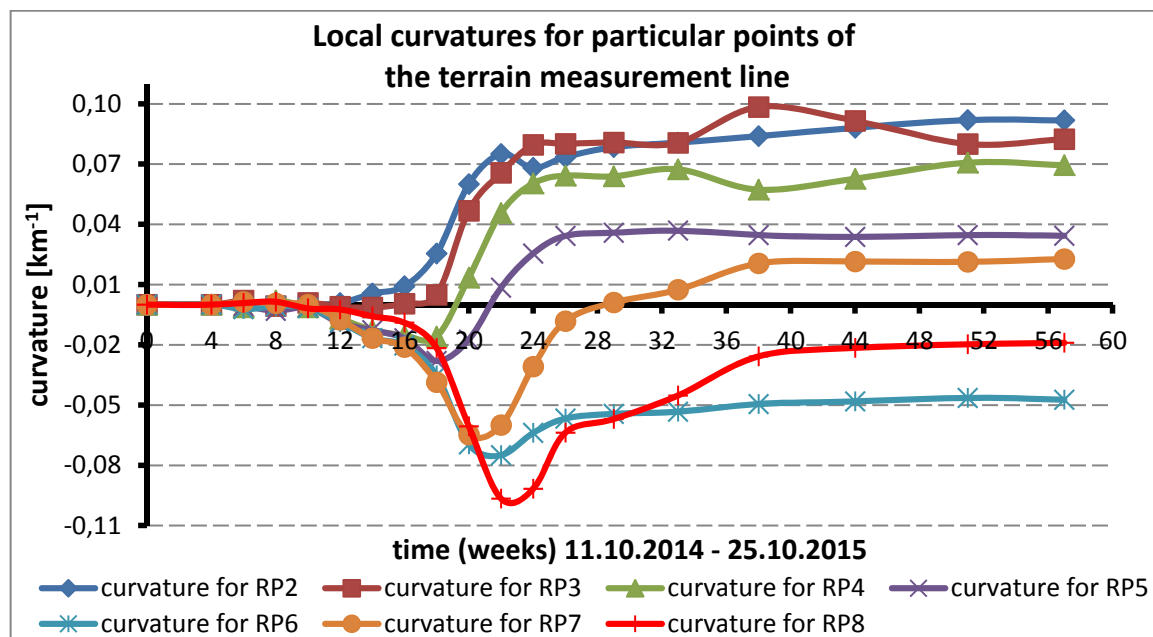
Fig. 7. Chart of local curvatures for particular points of the terrain measurement line
(Source: own elaboration)

At the beginning, the curvature of the land surface was increasing slowly. Till the moment an incomplete trough was shaped in the place of exploitation commencement, a slight concave curvature was observed in almost all points of the terrain line. Benchmark no. 2 was an exception, at which the curvature was convex from the very beginning. Together with the formation of the subsiding trough, the shape of which was similar to the final one, that is about 4 months from the commencement of exploitation the values of the curvature began changing dynamically. The biggest convex curvature was measured at points no. 2 and 3. Moving gradually away from the exploited field the value of the analysed parameter decreases till the moment an opposite sign is obtained. It means that at the benchmarks 6 and 8 there is a concave curvature. At point no. 7, in spite of initially formed concave curvature the convex shape was finally observed. The results are the confirmation of the thesis that locally the terrain curvature is a parameter which is variable and difficult to forecast [7]. The maximum curvature with a radius of about 10 km was observed at the benchmark no. 3, which corresponds to the 3rd category of mining damage.

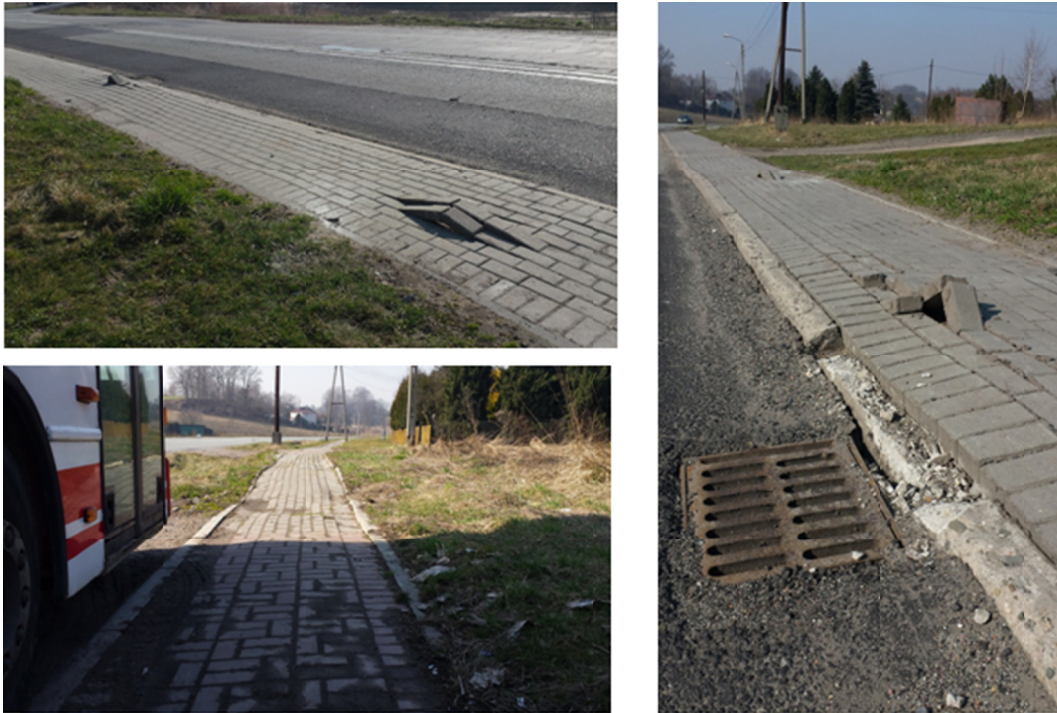
Photo 5. Pavement surface damage at the main street in Marklowice
(Source: own elaboration)

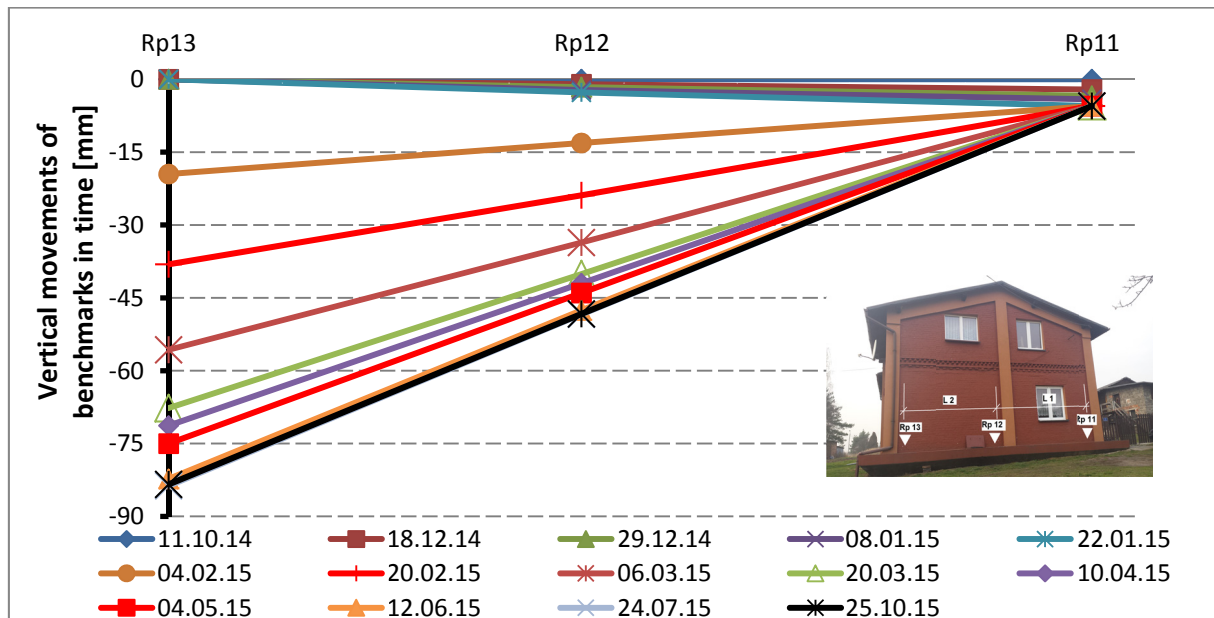
leaned, in the initial phase, slightly to north-east in the direction of the initial location of the exploitation edge. Then, together with rapid growth of ground deformation the building started to incline in the opposite direction (Fig. 8,9). The change in the tilt direction is associated with the fact that the exploitation front ran below the building. At the beginning, it was located to the northwest of the building and then moved southwest.

Fig. 8. Vertical movements of benchmarks on the east wall of Building No. 1
(Source: own elaboration)

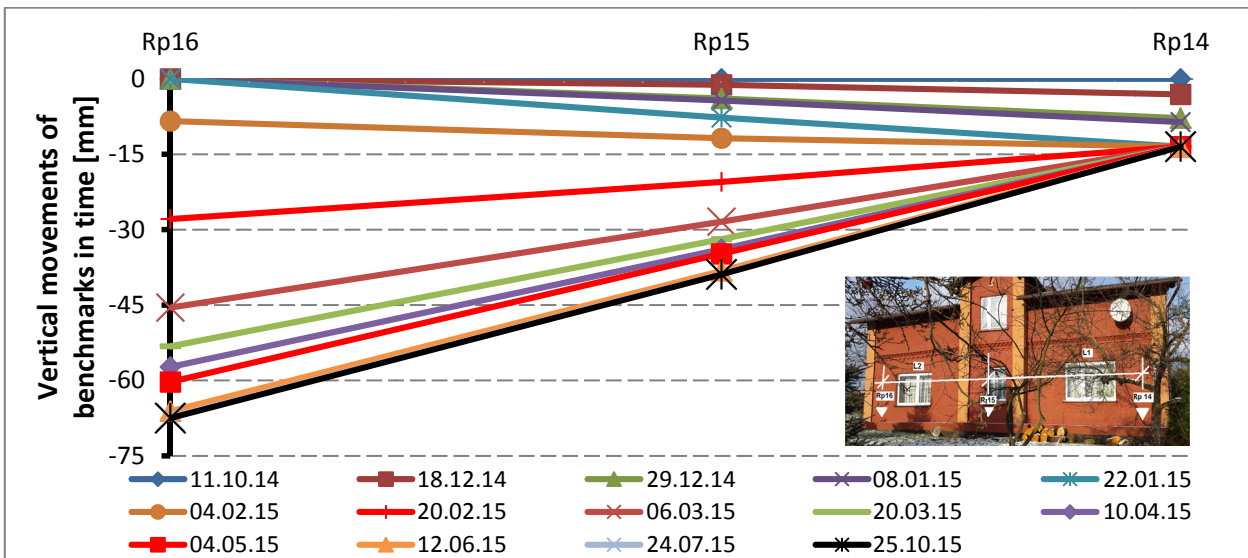
Fig. 9. Vertical movements of benchmarks on the south wall of Building No. 1
(Source: own elaboration)

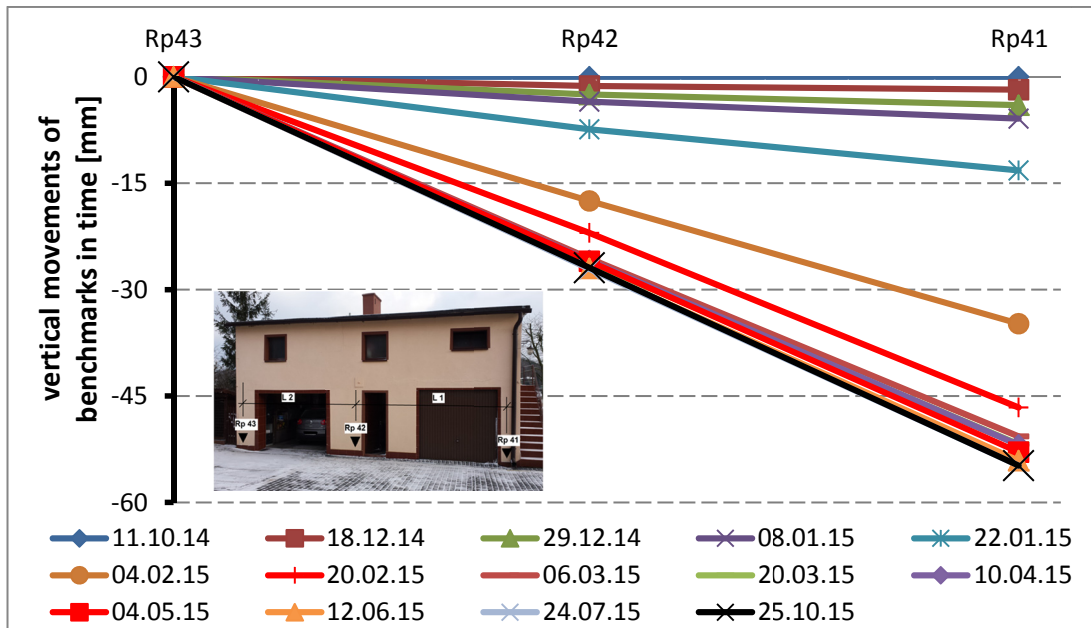
The other two buildings (no. 4g and no. 6) which were situated approximately over the initial edge of exploitation were leaning all the time in one direction only – inwards the exploitation field (Fig.10, 11). After performed exploitation all buildings remained leaned.

Fig. 10. Vertical movements of benchmarks on the west wall of Building No. 4g
(Source: own elaboration)

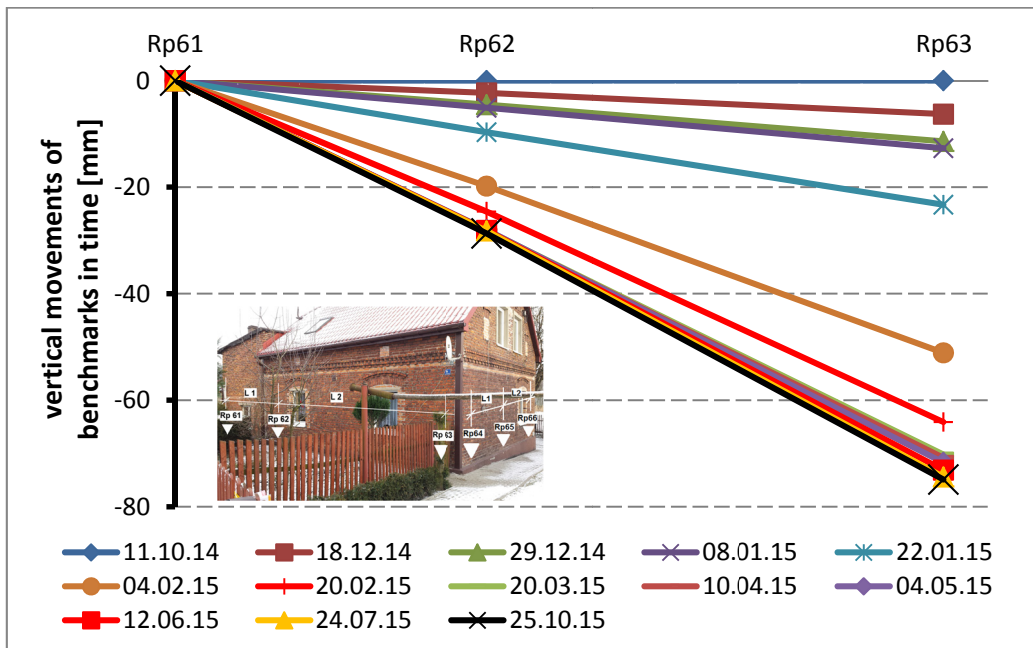
Fig. 11. Vertical movements of benchmarks on the west wall of Building No. 6
(Source: own elaboration)

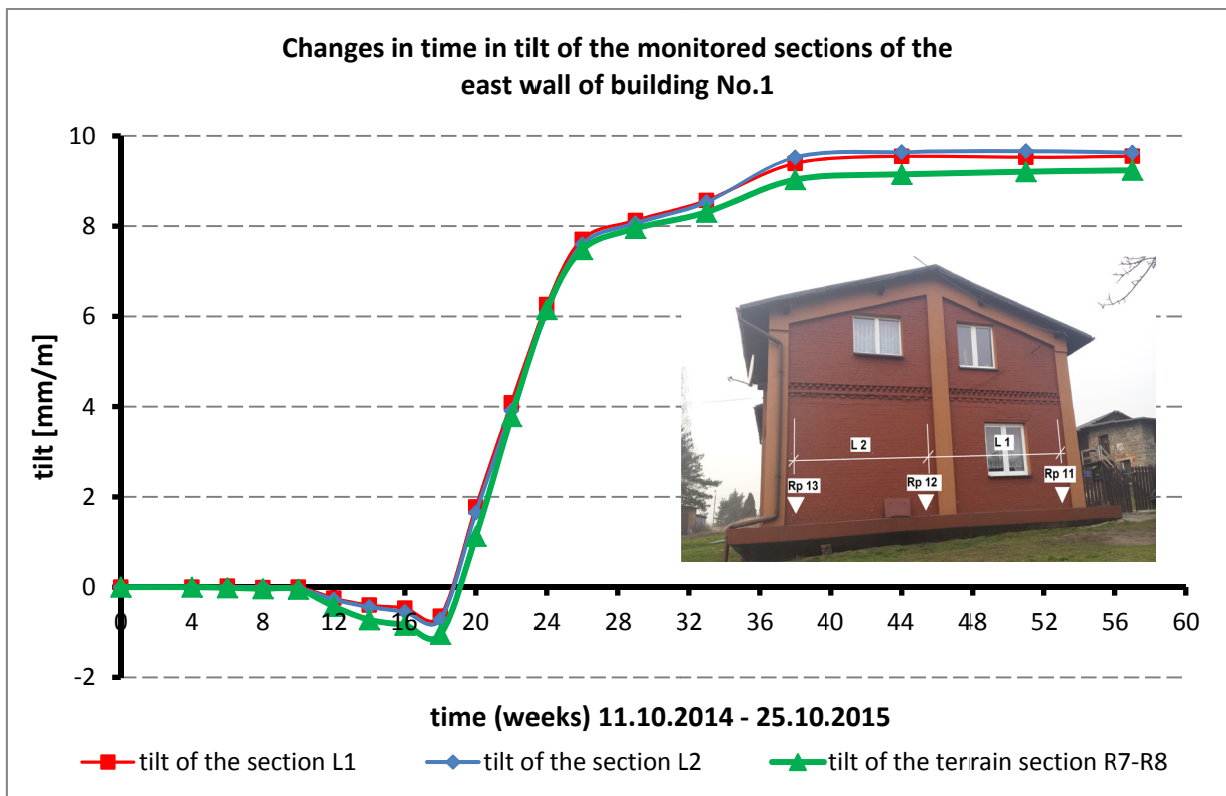
The building used to lean in line with the ground movements in that place. In the first phase, a slight tilt was observed towards the first location of the exploitation front of nearly 1 mm/m. Then, along with the movement of the longwall under the building, a change in the tilt direction took place, which was of more dynamic nature. Finally, the building remained in the leaning position in comparison with the initial state of

Fig. 12. Changes in time in tilt of the monitored sections of the east wall of Building No.1 along with changes in the ground inclination in the direct vicinity of the building
(Source: own elaboration)

about 10 mm/m, towards the inside of the exploited field. It is worth noting that the tilts of lines L1 and L2 do not run along the same track. It can be connected with the limited accuracy of geodetic measurements, but on the other hand, it can also signify the occurrence of the building deformation. Damage to the building visible in the photos (Photo 6) confirms that thesis. It was taken after the exploitation front had passed in September 2015.

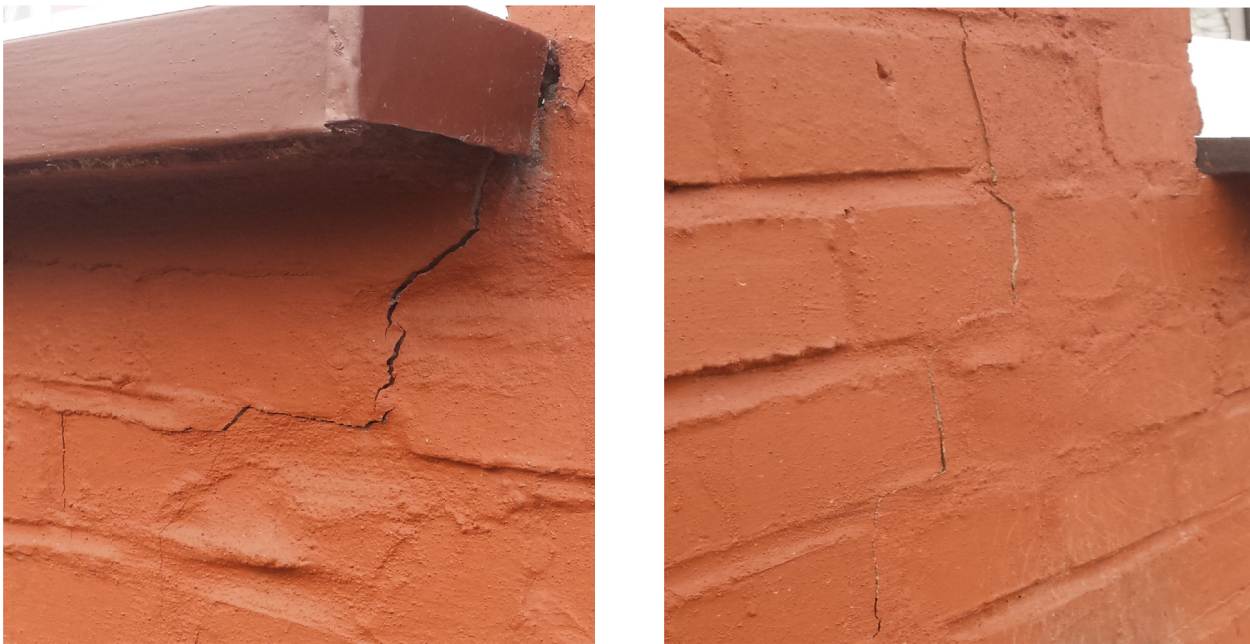
Photo 6. Technical condition of the monitored building after the exploitation front passed, September 2015
(Source: own elaboration)

Before the commencement of exploitation works the building was renovated. Its elevation had no signs of scratches and damage. When the exploitation front had passed cracks appeared. They concentrated mainly in the vicinity of window openings. It has to be borne in mind, however, that the building in question had been damaged many times in the past as a result of the mining activity. Each time actions were taken in order to repair the damage. It was not, however, insignificant for the rigidity of the building. The building was constructed in brick-and-mortar technology. Such types of building structures get significantly weakened after the first damage and it is difficult to restore them to their original stiffness [6].

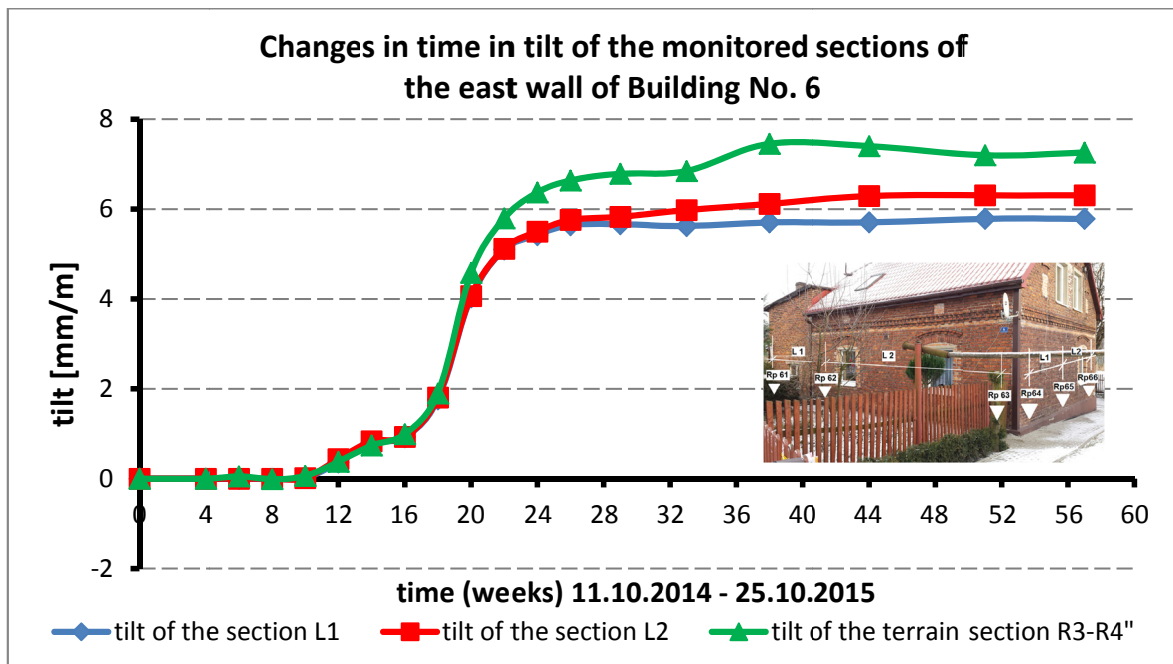
Thus, compiling the chart for the building no.6 situated exactly over the initial edge of exploitation, it is possible to come to a conclusion that it was deformed to even larger extent than the building no. 1 (Fig. 13).

Fig. 13. Changes in time in tilt of the monitored sections of the east wall of Building No.6 along with changes in the ground inclination in the direct vicinity of the building
(Source: own elaboration)

It is easily visible here that the tilt of particular fragments of construction is different in size (curves L1 and L2). It should, however, be pointed out that it is a two-segment building. Increasing ground deformation could result in the opening of the expansion joint between the two independent parts of the building structure. As proof of such an actual state is the fact that during the conducted research no damage was found in the structure of the building no. 6. In that case, it is most likely that the expansion joint protected the building against the formation of scratches. The problem of building division in aim of decreasing of structures internal forces was considered earlier and published in [5, 4]. Results of that consideration were published in regulation [2].
