Results of the Ground Surface Deformation Measurements in the Zone of Commencing the Roof Caving Exploitation and the Assessment of Its Impact on Buildings

Abstract

The article presented the results of periodic geodetic measurements, which embraced both the land surface and buildings in the zone of commencing mining exploitation. Classical geodetic measurements (levelling and tachymetric) were carried out in order to determine the size and nature of the mining ground deformation, the pace of change and their impact on the existing building development. The final results of the surface deformation were also compared with the forecasts prepared by the mine. The measurements lasted 13 months. During that period 19 measurement cycles were performed.

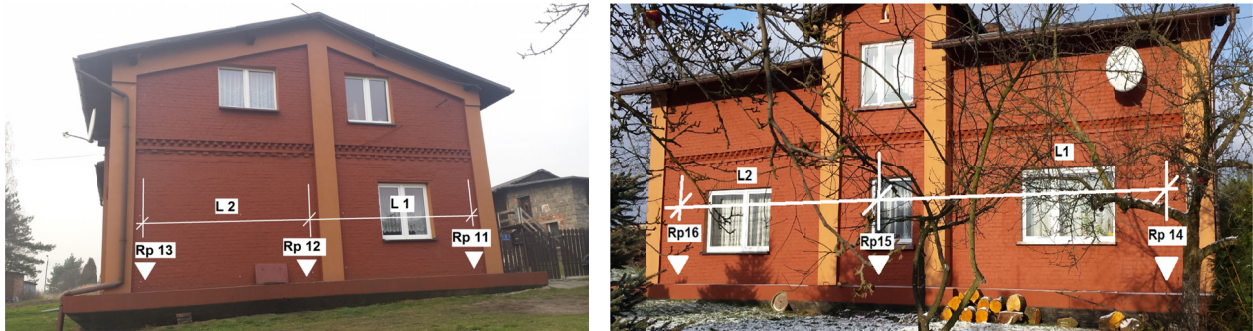
Photo 1. East and south wall of the residential building at 1 Świerkowa St.
(Source: own elaboration)

No. 1 is a two-storey building with a basement 14.2×9.4 m in size. It was constructed in 1930's using the traditional brick-and-mortar technology with wood ceilings and roof, and with the brick foundation. In the past it was damaged many times and then repaired as a result of mining activity [source: Marcel Coal Mine]. In 2009 the building was strengthened by means of a reinforced concrete band with a cross-section of 70×100 mm at the foundation level – fixed along the whole perimeter. The strengthening element is visible in the photos (Photo 1).

Six benchmarks in total were fixed at the level of +0.5 m (3 on the south wall and 3 on the east wall – Photo 1), which were used to perform periodical height measurements.

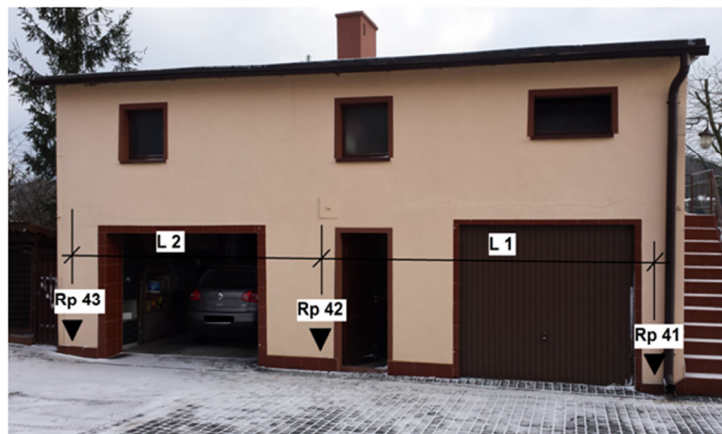
Photo 2. West wall of the utility building at 4 Świerkowa St.
(Source: own elaboration)

No. 4g is a one-storey building with an attic. It was built in brick-and-mortar technology with dimensions of 10.1×6.6 m in horizontal projection.

In order to carry out geodetic monitoring of the building, 3 benchmarks were fixed on the west wall at the level of +0.3 m (Photo 2). The shorter wall of the building was not monitored because in case of such short sections it is difficult to observe deformation of a building by means of geodetic methods. It is affected by measurement errors, which in case of small distances between benchmarks can achieve significant values.

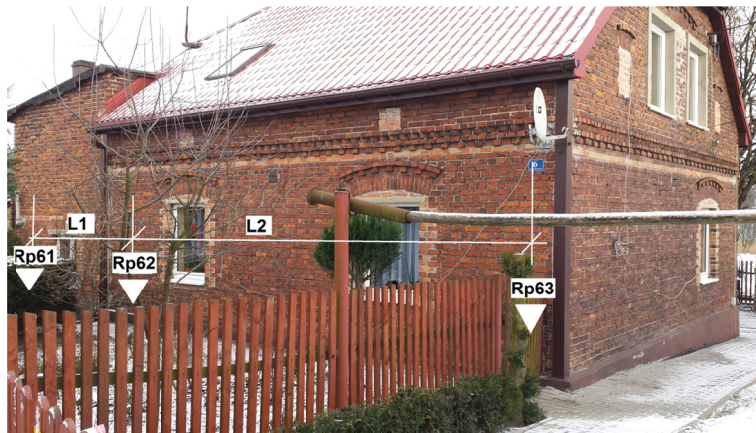
Photo 3. West wall of the building at 6 Świerkowa St. (Source: own elaboration)

residential part has a basement and utility attic. The utility part of the building has not got a basement. In this building the exterior wall, which is common to the both parts, was monitored. It is visible in the photo (Photo 3).

3 benchmarks in total were fixed on the western wall of the building at the level of +0.5 m. Two of them are on the residential segment and the third one on the utility one. Monitoring of vertical movements for this building was planned in order to examine how the deformation of the building will be influenced by the fact that it was provided with an expansion joint.

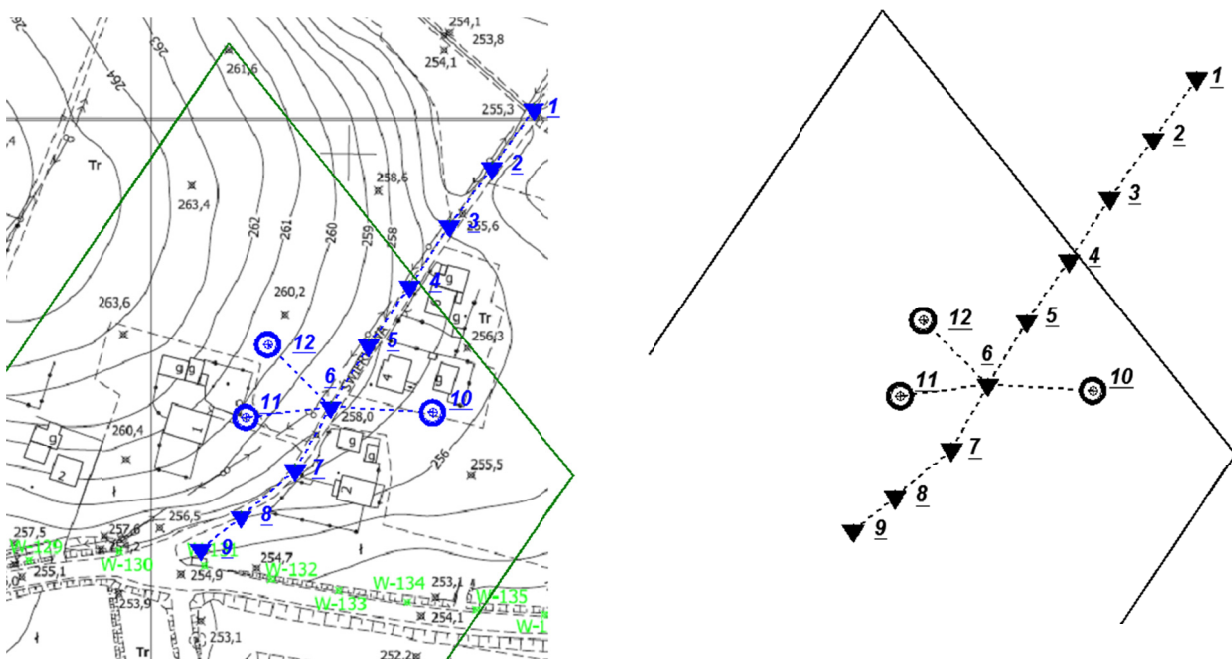
Fig. 3. Location of points representing the land surface (Source: own elaboration, based on data from the Marcel Coal Mine)

points were also stabilised in the direct vicinity of the line. Points no. 6, 7, 8 (Fig. 3) are common to both the measurement line and the rosette. Stabilization of all points was performed on 16.09.2014. Each installed geodetic field mark is a steel rod set at a depth of 1.3 m below the surface on the concrete foundation. Holes around the rods needed for execution of the concrete foundations were filled thoroughly with native soil in accordance with guidelines [9].

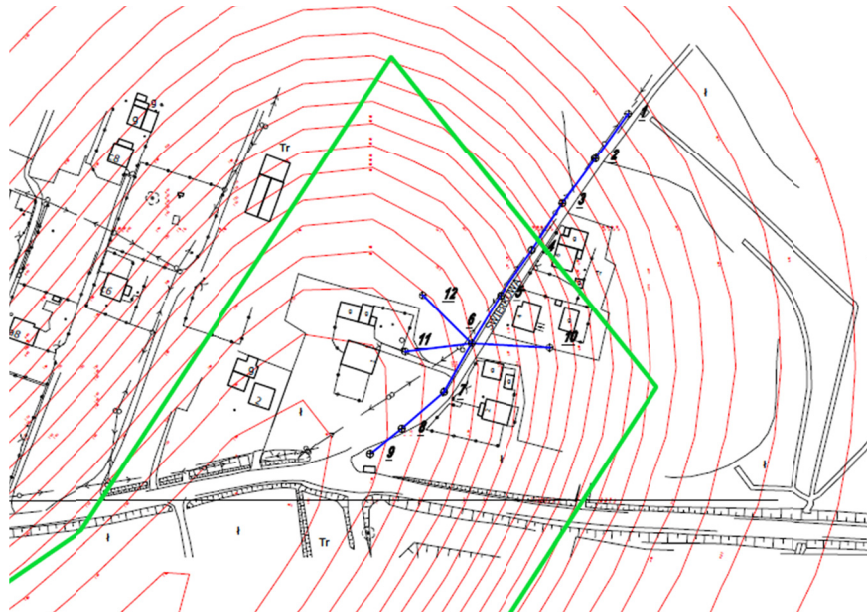
Fig. 5. Forecast trough of subsidence caused by exploitation of the W-5 longwall with marked location of the terrain line (Source: Material prepared by the Marcel Coal Mine)

The measured difference in subsidence between the extreme benchmarks of the terrain measurement line is close to the forecast value. On the other hand, the shape of the predicted edge of the subsiding trough diverges slightly from the real one, which was determined on the basis of the field measurements.
